Enhancing Geotechnical  
Information with Ground  
Penetrating Radar

Final Report

No.		1. Report	2. Gov. Accession No.	3. Recipient's Catalog No.
FHWA-NH-RD-12323U				
4. Title and Subtitle Enhancing Geotechnical Information with Ground Penetrating Radar			5. Report Date April, 2002

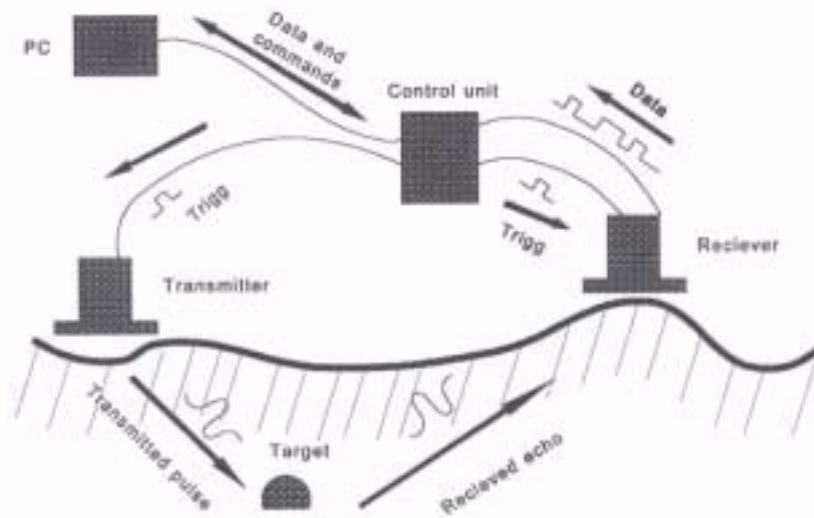
*Figure 1: GPR schematic. The radar control unit is connected to a laptop computer through a parallel communications cable and to the transmitter and receiver through fiber optic cables.*

GPR operates by transmitting pulses of radio waves into the ground through an antenna. The transmitted energy is reflected from contacts between different earth materials. When the transmitted signal enters the ground, it contacts subsurface strata with different electrical conductivities and dielectric constants. Portions of the radar waves are reflected off a subsurface interface, while the rest of the waves pass through to the next interface. The digital control unit receives the reflected waves after they have returned through the antenna. The control unit registers the reflections against a two-way travel time, then amplifies the signals and sends them to a computer. The computer takes the output signals, representing reflected surfaces, and plots them on the radar profile as different color bands.

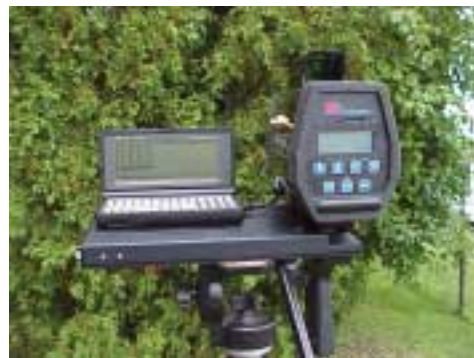
*Figure 8: Laser gun & profiler*

When the survey wheel was unable to track the distance traveled, a Trimble GPS (Figure 7) was used. This was particularly useful for obtaining the locations of profiles collected over water. The locations of the profiles could easily be placed on the project plans by collecting the positional data with the GPS. A laser profiler (Figure 8) was also used to help locate seams and fractures on the face of a rock cut and a digital camera (Figure 9) was used to help document pertinent project information.

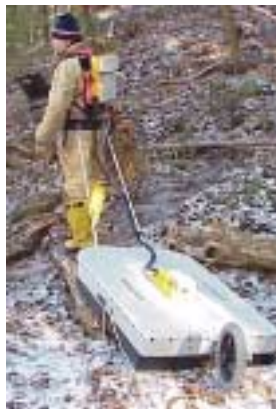
*Figure 11: GPR unit fully assembled & being towed over the ground surface*

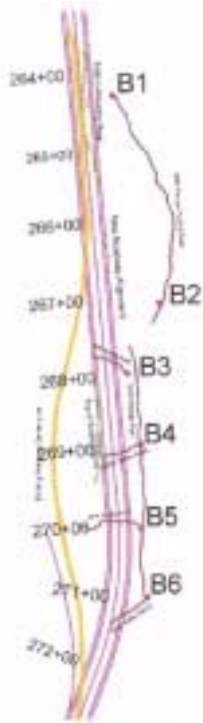
Figure 13: Map view showing test borings & GPR locations with both roadway alignments

Route 112 is a two-lane highway within the White Mountain National Forest (Figure 10). A project is proposed to resurface and straighten six kilometers of this highway. Test borings were conducted at several key areas of the project. One such area was approximately 300 meters of new roadway alignment that went into the woods, eliminating a large curve in the road. Six test borings were conducted along a portion of the new alignment. The depth to bedrock at locations between the test borings became a concern after reviewing the test boring data and observing the surface topography and the existing rock outcrops. GPR was deployed to determine the depth to bedrock within these areas (Figure 11). The test boring data revealed relatively clean sands and gravel over bedrock at varying depths. GPR profiles were collected over varied terrain with an outside temperature of 15°F (Figure 12). The 100 MHz antenna was used because the depth to bedrock was expected to be greater than four meters in many locations. Two profiles were collected parallel to the proposed alignment and four profiles were collected perpendicular to the proposed alignment. This would aid in drawing the bedrock lines on the project cross sections. A surveyed centerline with stationing was not available in the field, so a GPS receiver was used to locate where the profiles had been collected relative to the test borings. The positional data for the test borings and the profiles were viewed on the project plans using ArcView GIS (Figure 13). Bedrock lines were drawn on the project cross-sections by correlating the profile and test boring data to centerline stationing on the project plans.

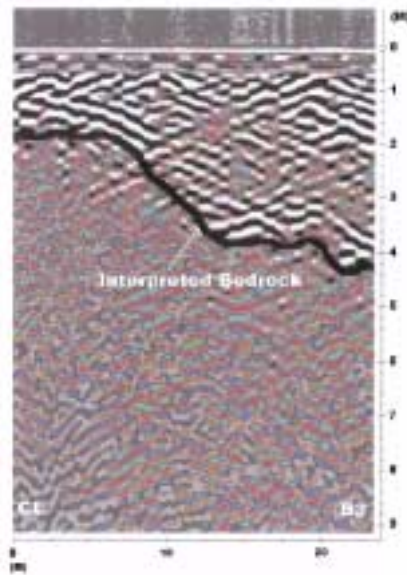
Figure 14: GPR profile, going from EOP to B3 perpendicular to the roadway alignment

The radar profiles were calibrated using the test boring data by adjusting the velocity of the radar waves to match the depths at which the test borings intercepted the bedrock. Figure 14 is a GPR profile perpendicular to the roadway alignment, without topography correction, showing the interpreted bedrock line starting from the edge of pavement and going to boring B3. Figure 15 is the profile collected by pulling the radar unit from test borings B6 to B3, parallel to the roadway alignment. Boring B6 encountered bedrock at a depth of 3.4 meters, B5 at a depth of 3.4 meters, B4 at a depth of 1.2 meters and B3 at a depth of 4.0 meters. Both of these profiles demonstrate how GPR was able to provide detailed subsurface information in the areas between and adjacent to the test borings. This information was used in designing the cut slope for this section of the new roadway alignment.

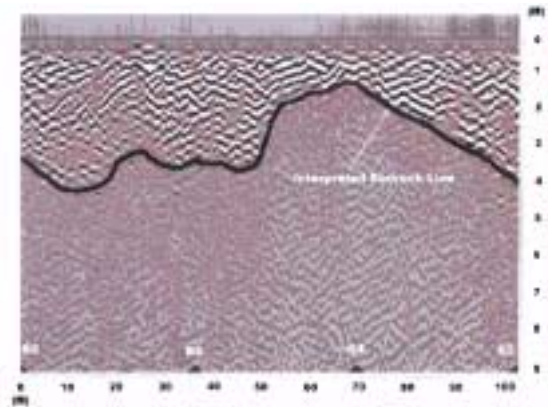
Figure 15: GPR profile between test borings B6 & B3, parallel to the roadway alignment

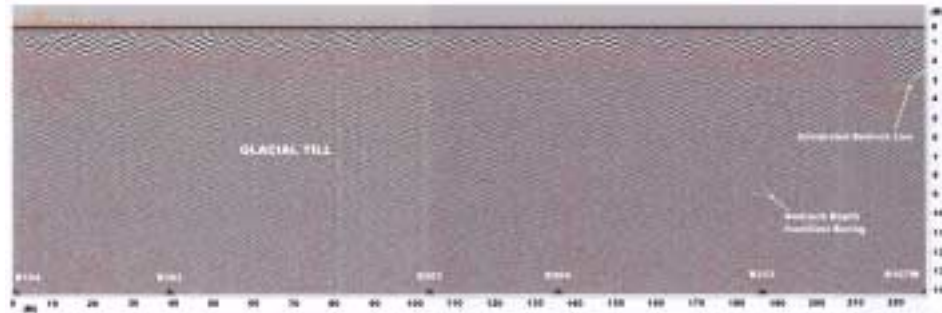
*Figure 17: Test borings indicate that bedrock rises from below the profile bottom on the left to a depth of 3 meters at the right. The glacial till was absorbing the radar energy below 4 meters of depth*

Figure 17 is a radar profile collected from the first location along the new roadway alignment. Roadway cuts of approximately 14 meters in depth are proposed. An accurate representation of the bedrock surface is required to make the appropriate roadway cut designs. At one end of the cut the test borings indicated that bedrock was relatively deep, approximately 17 meters, and at the other end of the cut they indicated it was relatively shallow, approximately 3 meters. The profile indicates that the radar waves were unable to penetrate the glacial till beyond a depth of approximately 4 meters. The only location where bedrock appears on the profile is where it rises above 4 meters in depth, which is along the last 15 meters of the profile. Three additional test borings were placed along this portion of new alignment to confirm the depth to bedrock between test borings B104 & B213. Figure 18 is another radar profile collected from a different section of the new roadway alignment. Roadway cuts of approximately 6

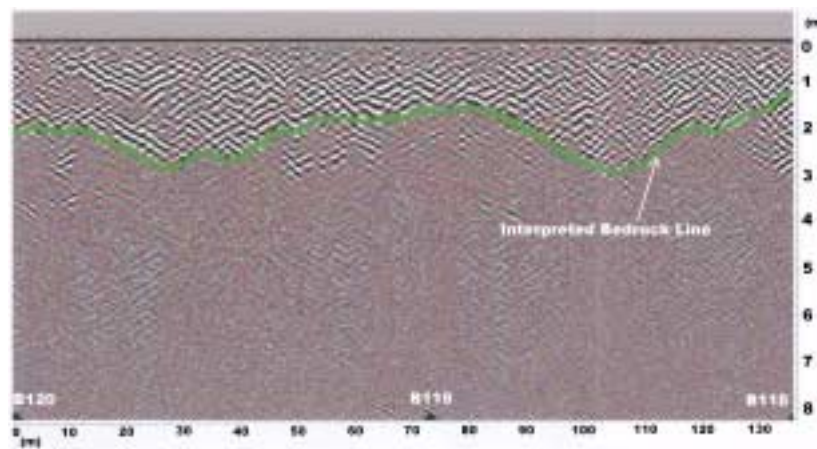
*Figure 18: The interpreted bedrock line from the radar profile correlating well with the test boring data*

meters are proposed in this area. At this location the bedrock is around 2 meters in depth, rising higher in some places and lower in others. Bedrock depths taken from the test borings were used to help calibrate the profile's depth scale. Boring B120 encountered bedrock at 2 meters, B119 at 1.4 meters, and B118 at 1.2 meters. The profile's interpreted bedrock line closely matches the depths at which the test borings encountered bedrock, except at boring B118 where the exact location of the test boring could not be determined because of snow cover. At this location the radar unit probably was pulled near the test boring and not actually over it.

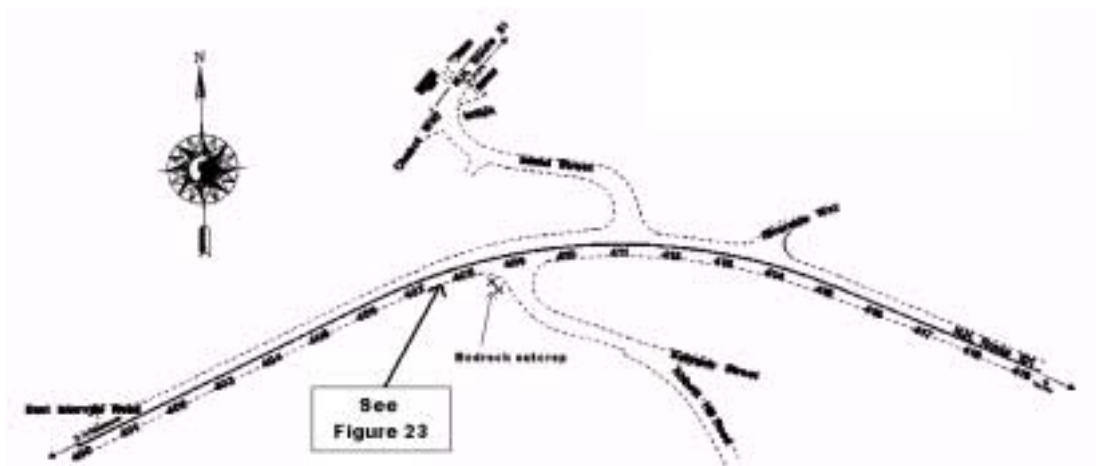
Figure 19: Copy of “as-built” plans minus some of the details

This project involved excavating further into an existing roadway cut slope to improve the sight distance at an intersection. The depth to bedrock at a specific offset from the roadway centerline was needed to design the proposed cut slope and to determine the potential impact of the work. Specific challenges included having old “as-built” plans (Figure 19), no survey staked in the field, and the need to have results within a few days. Time constraints ruled out the possibility of mobilizing a drill rig and exposed bedrock at the corner of the intersection indicated that bedrock would be encountered within the limits of the project. To determine where bedrock might be encountered along the slope, a couple of GPR profiles were collected parallel to the roadway alignment. A geological site reconnaissance revealed that the expected soil conditions would be sand over bedrock. Since project plans and survey were not available, an estimate was made as to how far the slope would be cut back. The depth to bedrock was unknown so the 100 MHz antenna was used for maximum depth penetration and velocity estimates were made to calibrate the depth scale. Figures 20 & 21 are photographs of the project site showing the cleared path for the radar unit and the estimated locations of the survey stationing.

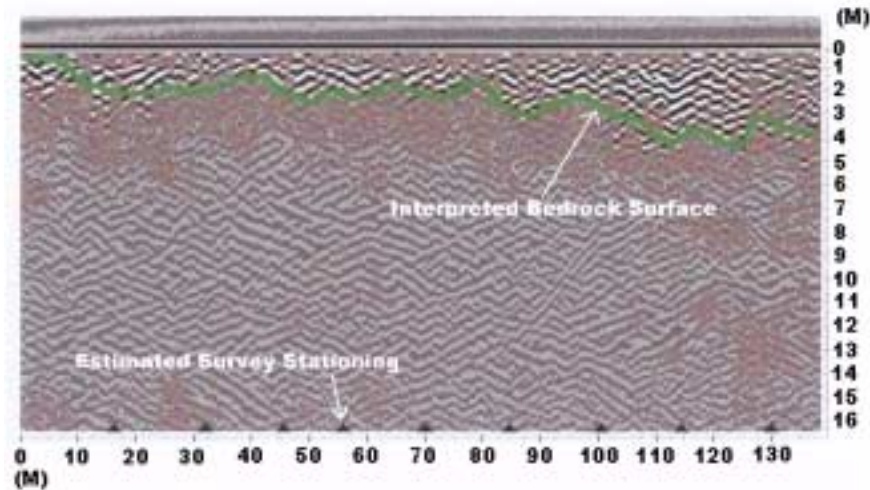
Figure 22: Interpreted bedrock line with the estimated survey stationing for the profile collected along the embankment

Figure 22 is one of the profiles collected at the site. The green line represents the interpreted bedrock surface and the marks at the bottom of the profile are the estimated survey stationing from the old “as-built” plans. In order to determine the depth to bedrock on the profile, the radar unit was started near the corner of the intersection where bedrock was very close to the ground surface. The interpreted bedrock line was drawn at the boundary between the two distinct surfaces shown on the profile, except at the beginning of the profile where our assumption of having bedrock close to the ground surface was used. During the construction phase of this project bedrock was encountered within the cut slope. Accurate elevations of the bedrock surface were obtained and plotted on the cross sections with the original ground surface, the new ground surface, and the interpreted bedrock line (Figure 23). The cross section shown in Figure 23 displays how closely the interpreted bedrock line matches the actual bedrock surface measured during the construction phase of the project.

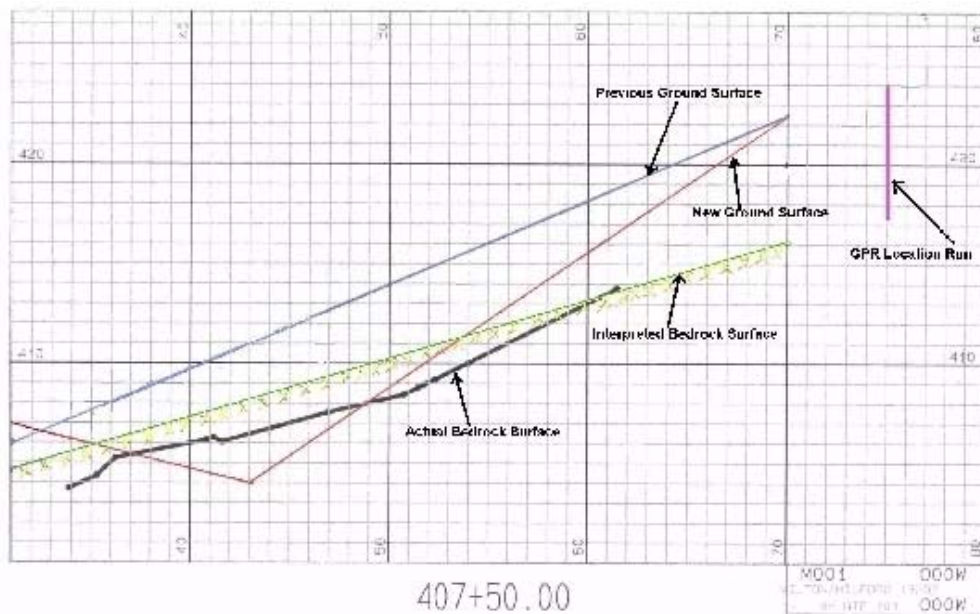
Figure 23: One of the final cross-sections showing the different surfaces and the actual location of where the radar profile was collected

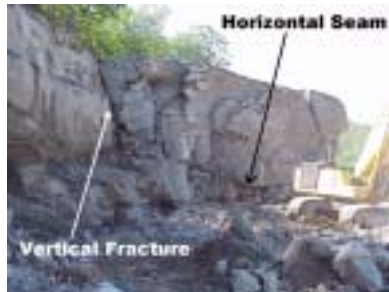
*Figure 24: Horizontal seam and vertical fracture*

Two weeks prior to bid advertisement, work within a rest area was added to a large interstate highway project. The additional work involved increasing the parking capacity of the rest area by cutting further back into a large, existing unstable rock slope and rehabilitating the existing rest area building. Time constraints ruled out the possibility of conducting a geotechnical investigation so a site reconnaissance was done to estimate the amount of soil cover over the existing bedrock. During construction, the stability of the rock cut became a concern because vertical fractures and large seams, dipping towards the parking area, were uncovered. Figures 24 through 26 show the dipping seams and

the vertical fractures along the cut face. The seams were filled with severely weathered rock and soil, and water was often observed seeping from them. A drill rig was mobilized in an attempt to locate the seams at a predetermined offset behind the face of the cut. A laser profiler was used to determine the elevation of where the seams were exposed on the face of the rock slope and GPR was used to determine the depth to the seams at areas between and adjacent to the test borings. The radar profiles were calibrated using the test boring and laser profiler data while existing survey data provided ground elevations for topography corrections above the cut.

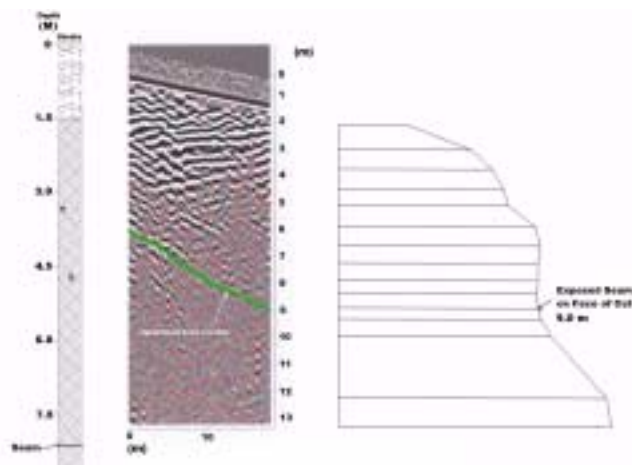
*Figure 27: Test boring log, GPR and laser profiles for station 709+50*

Figures 27 through 32 show the test boring logs, the laser profiles with seam locations, and the topography corrected GPR profiles. The radar profiles, in figures 27 through 31, start at the top of the rock slope and end at the test borings. The laser profiles start at the same locations as the radar profiles and end at the toe of the cut slope. The radar profile in figure 32 runs parallel to the face of the rock cut, at the same offset as the test borings, and provides subsurface information between the test borings. The depths at which the seams intersect the face of the cut, where the test borings intersect the seam, and where the seams are detected on the radar profiles, all indicate that the seam is continuous and dips towards the parking area. This information and the high potential for instability in the rock slope prompted changes in the design of the cut slope and parking area.

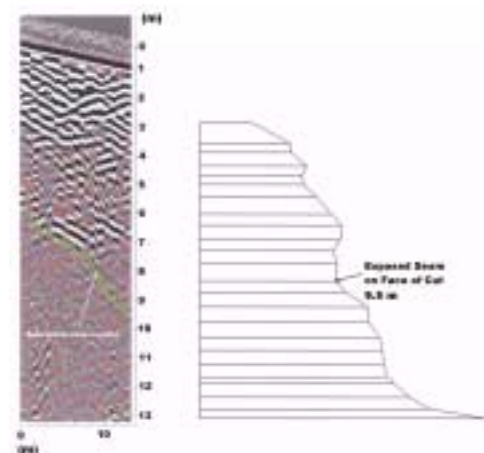
*Figure 28: GPR and laser profiles for station 710+00*

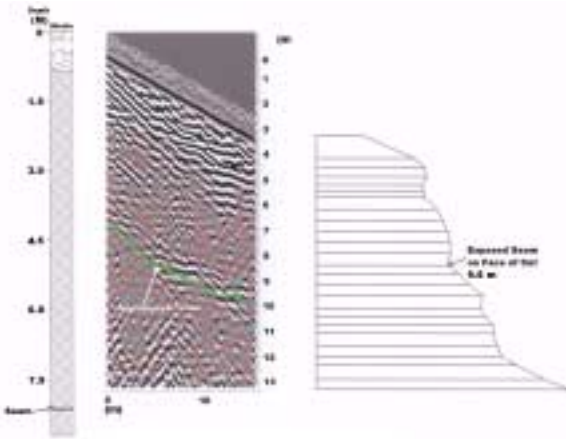
Figure 29: Test boring log, GPR and laser profiles for station 710+50

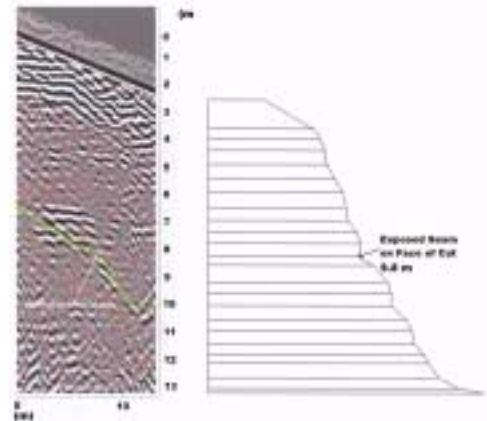
Figure 30: GPR and laser profiles for station 711+00

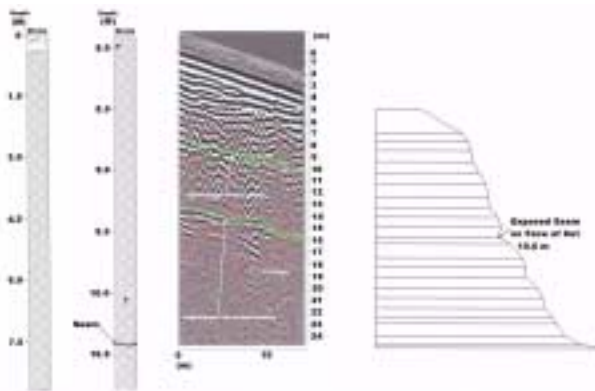
Figure 31: Test boring log, GPR and laser profiles for station 711+50

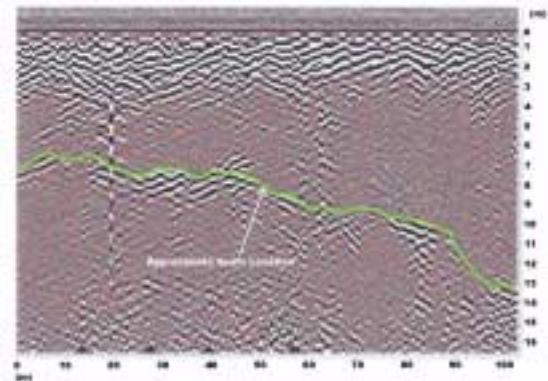
Figure 32: GPR profile parallel to the face of the cut depicting the seam

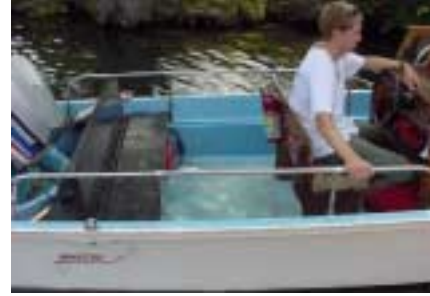
*Figure 34: The radar antenna was placed behind the seat*

This project involved acquiring a river bottom profile using GPR. The data collected with the radar unit was to supplement the existing test boring data. The existing plans and test boring data revealed water depths ranging between one and twelve meters across the width of the river. The test boring logs showed that silt, sand, gravel and glacial till were overlying bedrock, which ranged from six to forty meters below the bottom of the river. To collect the profiles, the radar unit was placed in the bottom of a motorized fiberglass boat (Figures 33 & 34). A laser gun was used to measure an offset to the centerline of the new bridge from the existing bridge structure on each side of the river. A GPS was linked to the radar unit and used to track the location of where the radar data was collected. This allowed positional data to be attached to every trace in the profile and for a precise line to be drawn depicting where the radar unit collected its data (Figure 35).

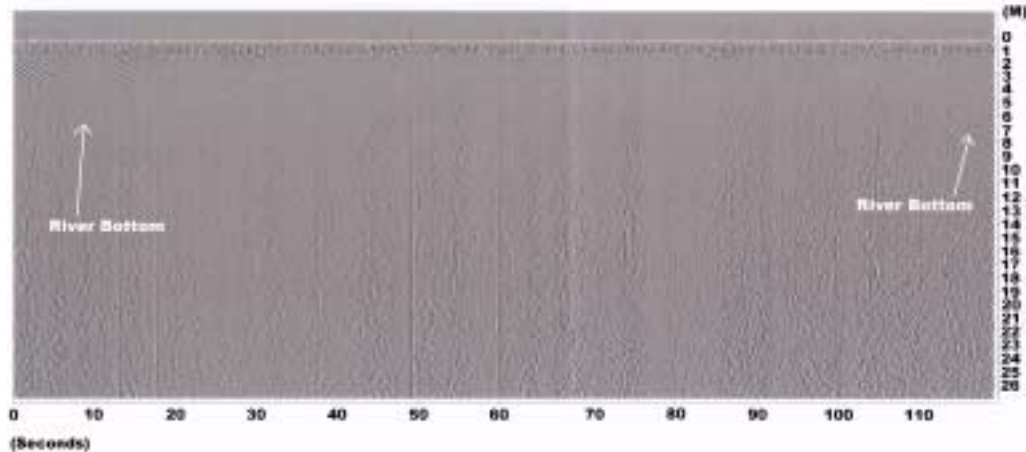
*Figure 36: River bottom profile from VT side of river, going east to west.  
The river bottom is only visible on the sides of the river*

Two profiles were collected at this site using the 100 MHz antenna. The data acquisition mode was changed from distance to time because the survey wheel was not being used as a trigger source for data collection. The river water was cloudy and contained a fair amount of sediment and visibility was limited to about a meter. Figure 36 shows the profile collected from the channel closest to the Vermont side of the river. The radar waves penetrated through the water down to a depth of about 7 meters and maybe another meter or two into the sediment. The river bottom is only visible at the beginning and at the end of the profile, which correlates to the edges of the river where the water depth is minimal. Towards the middle of the profile the depth of the water becomes greater than what the radar signal can penetrate and the river bottom is no longer visible. Figure 37 is the profile collected along the channel closest to the New Hampshire side of the river. Like the profile on the Vermont side, the river bottom is only visible at the beginning and at the end of the profile. Towards the middle of the profile the radar energy is attenuated before it reaches the bottom of the river. The high amount of suspended sediment in the river along with the water depth provide likely explanations for not detecting river bottom reflections away from the banks of the river.

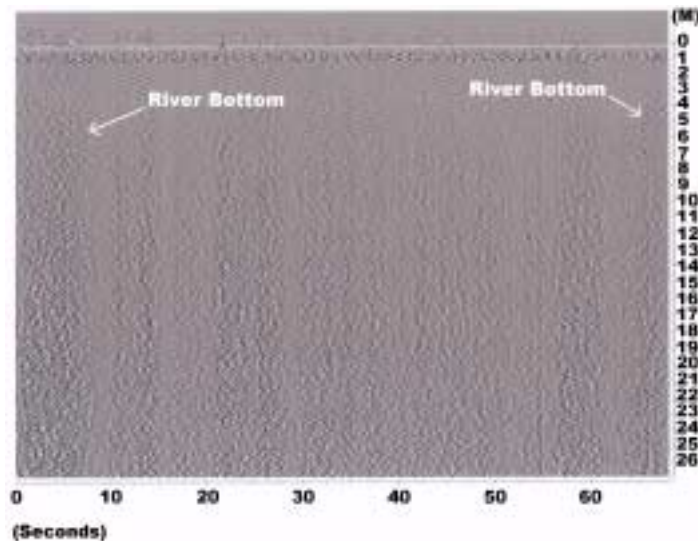
*Figure 37: River bottom profile from NH side of river.  
The river bottom is only visible on the sides of the river.*

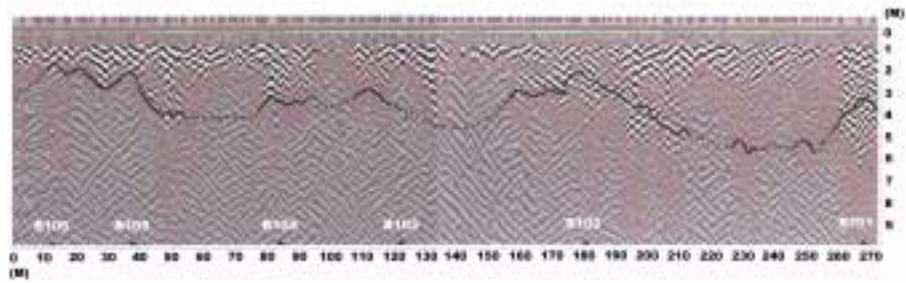
Figure 39: Profile along embankment, solid line indicates bedrock was confirmed with test borings, dashed lines are estimated bedrock surfaces

Figure 38 is a photograph of the road depicting where the subsurface investigation was undertaken. A 783-meter profile was collected along the west side of the road using the 100 MHz antenna. Figure 39 is a portion of the profile collected in the area of the proposed cut into the existing slope. The profile was collected at the base of the cut slope, offset a few meters from the test borings and 2.5 meters lower in elevation. There were buried utilities along the base of the existing cut slope and within a couple of meters of where the radar profile was collected. The 2.5-meter elevation difference was subtracted from the test boring data, so the radar and test boring data could be compared. The profile appears to correlate with the test boring data at borings B106, B105 and B104, but does not correlate with the test boring data at borings B103, B102 and B101. At some of the locations between the test borings, the

validity of the radar data appears to be questionable. The profile's interpreted bedrock line is solid where the correlation between the test boring and GPR data is good and dashed where the correlation is poor.

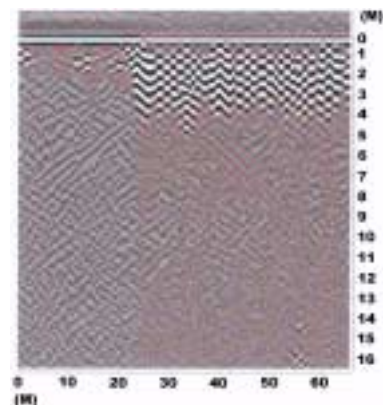
Figure 41: Intersection Profile. Notice profile change from asphalt to concrete

This roadway project involved the reconstruction of the intersection shown in figure 40. Test borings were conducted and GPR profiles were collected to determine the soil and bedrock conditions at this site. The radar profiles that were collected off the roadway surface indicated that bedrock was shallow, which was confirmed by nearby test borings. These borings encountered bedrock along the left side of the road at 1.0 meter and along the right side of the road at 3.4 meters. Several GPR profiles were collected to determine if bedrock would be encountered within the middle of the intersection. Traffic concerns eliminated the possibility of drilling test borings in the middle of the intersection for bedrock depth confirmation. Figure 41 is a profile collected by pulling the radar unit down the center of the road as shown in figure 40. The profile starts on the pavement and goes onto the concrete median for a total length of 70 meters. When comparing the pavement section of the profile to that of the concrete section there is a distinct difference in signal penetration. Possible explanations for these differences could be that aggregate within the pavement attenuates the radar signal or dissolved roadway salt is within the pores of the pavement. The difference in signal penetration makes the interpretation of the profile extremely difficult.

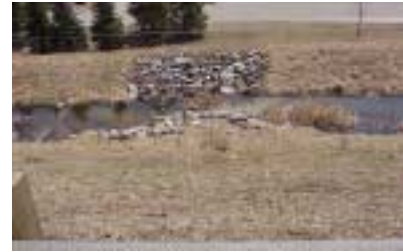
*Figure 44: Test boring wash water emerging at base of embankment*

This investigation was initiated because of a slope failure located on top of an embankment fill along a relatively new section of the Circumferential Highway (Figure 42). Voids were opening up on the ground surface (Figure 43) on the other side of the road and opposite the embankment failure. A drill rig was mobilized to drill holes through the pavement and the radar unit was set up to collect GPR profiles to determine if the roadway was in danger of failing or if voids existed below the roadway surface. It became apparent that water could easily travel beneath the roadway surface and through the fill because wash water from the drilling operations emerged from around a drainage pipe located at the base of the embankment (Figure 44).

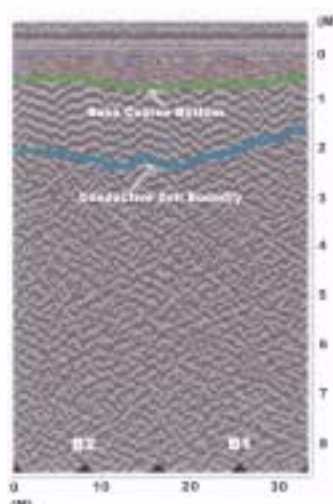
*Figure 47: GPR profile*

The profiles shown in figures 45, 46 and 47 were collected using the 500 MHz antenna and the profile shown in figure 48 was collected using the 100 MHz antenna. The profiles in figures 45, 46 and 47 show the bottom of the roadway's base coarse material and a soil boundary layer a meter or two lower in elevation. The marks at the bottom of these profiles represent the test boring locations. The profiles going from B4 to B2 (Figure 45) and B3 to B1 (Figure 46) are perpendicular to the roadway alignment and the profile going from B2 to B1 (Figure 47) is parallel to the roadway alignment. The profile in figure 48 runs parallel to the roadway alignment, six meters from the edge of pavement and next to the surface voids that are shown in figure 43. The marks at the bottom of this profile represent the location of the surface voids. The test boring logs (Figure 49) indicate that silty fine sands with layers of clay and gravel compose most of the embankment fill. Riprap or larger stone was not found to be present anywhere within the embankment fill. Neither GPR nor the test borings detected any subsurface voids. It appears that water flows from one side of the embankment fill to the other along the detected soil boundary and it washes out the side slope as it exits the embankment.

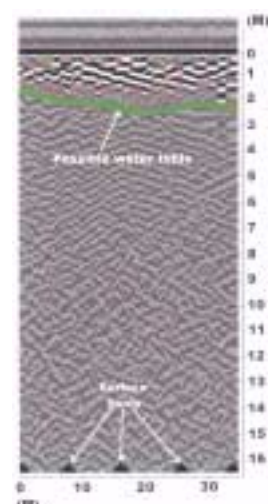
*Figure 48: GPR profile*

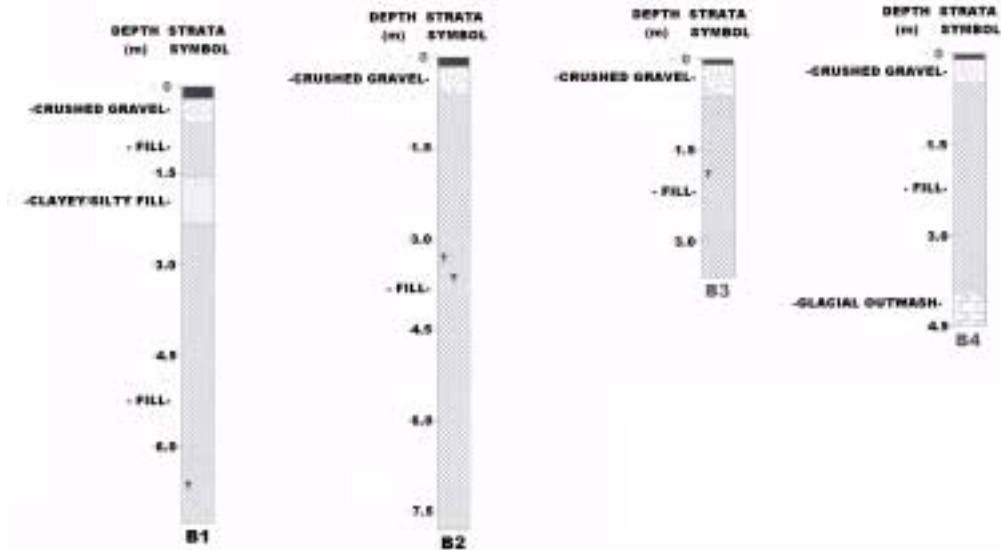
Figure 49: Test boring logs for the above GPR profiles, the water table is represented by darkened upside down triangles (Figures 45-48)
